Environmental Friendly Technologies and Measures
in the Energy Supply Sector

Technology for Enhancing Efficiency of Thermal Power Plant (Assessment of Equipment)

J-POWER

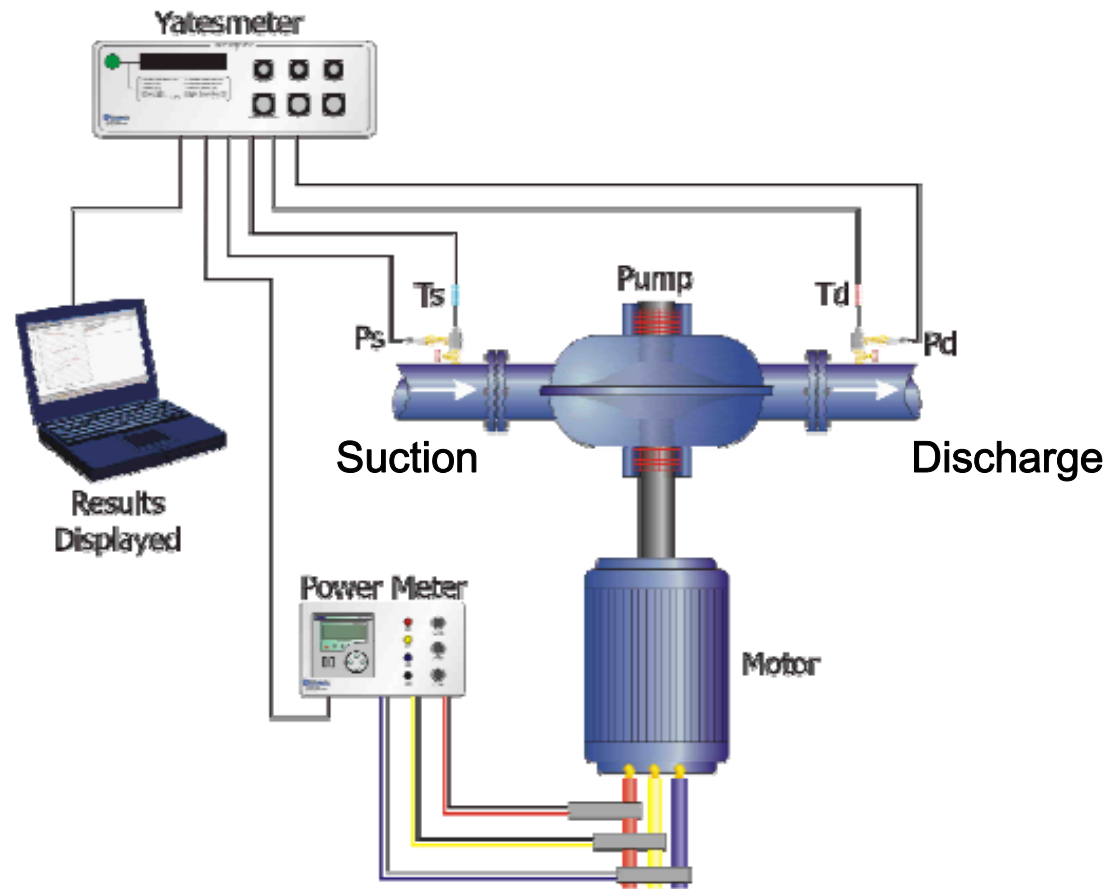
Measuring System

Yates Meter Theory (1/2)

**Work Input (W_{in})
= Work output (W_{out}) + Losses**

Pump efficiency : $E = W_{out} / W_{in}$

In pump, losses are heat energy to increase fluid temperature.

$$E = \frac{W_{out}}{W_{out} + Losses} = \frac{1}{1 + \Delta TC_p / gH}$$

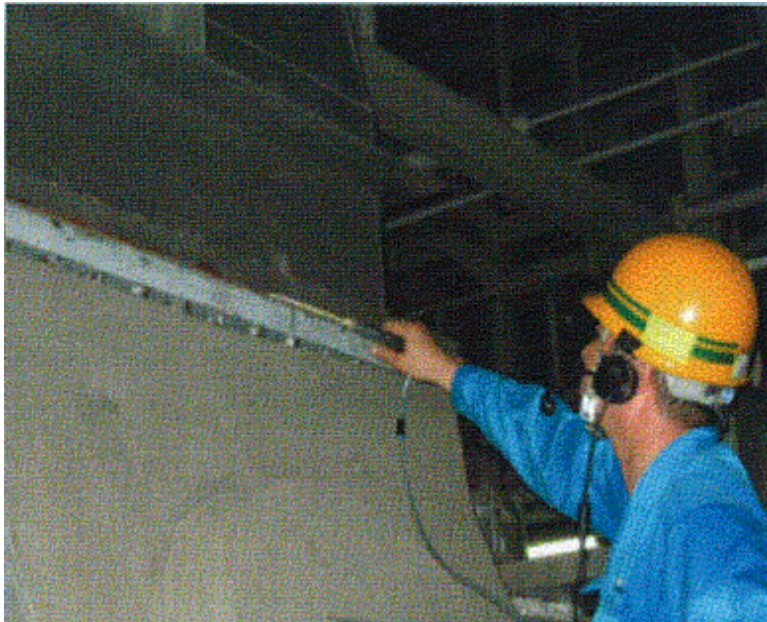
Helium Spraying

- 1) Chemical symbol : He
- 2) Specific weight: 0.14 (Air : 1.0)
- 3) High sensitivity
- 4) No impact to existing equipment, such as condenser, turbine and piping
- 5) Non toxic

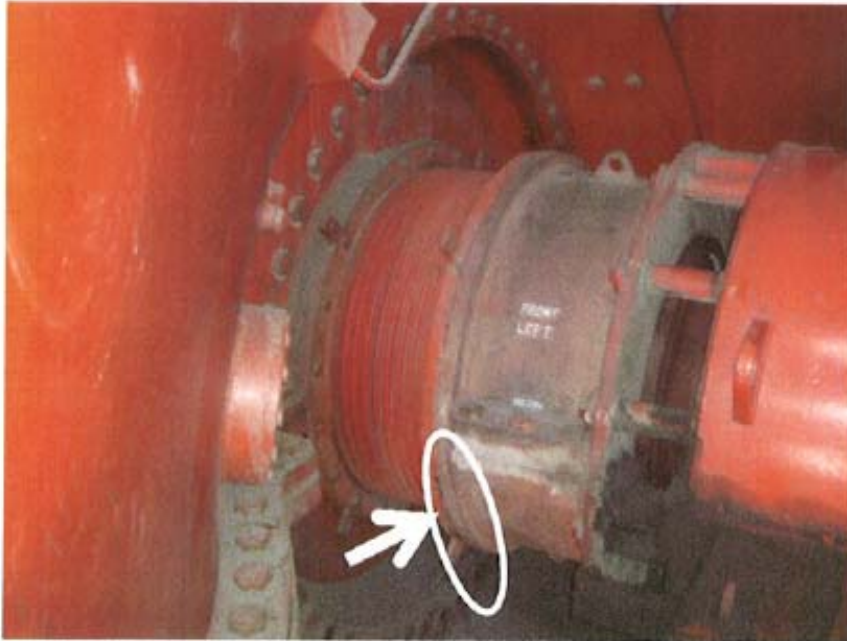
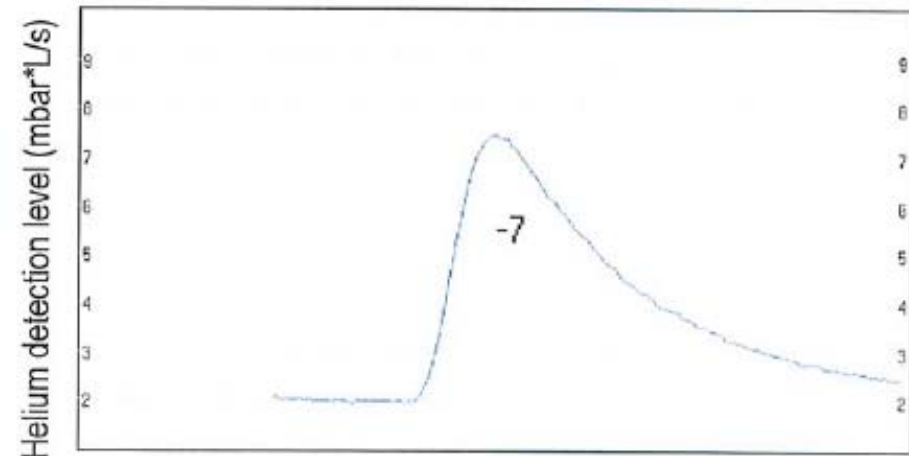
LP Turbine Gland

Max. Value
Air ingress volume

7.46×10^{-7}
Approx. 2.2 kg/h

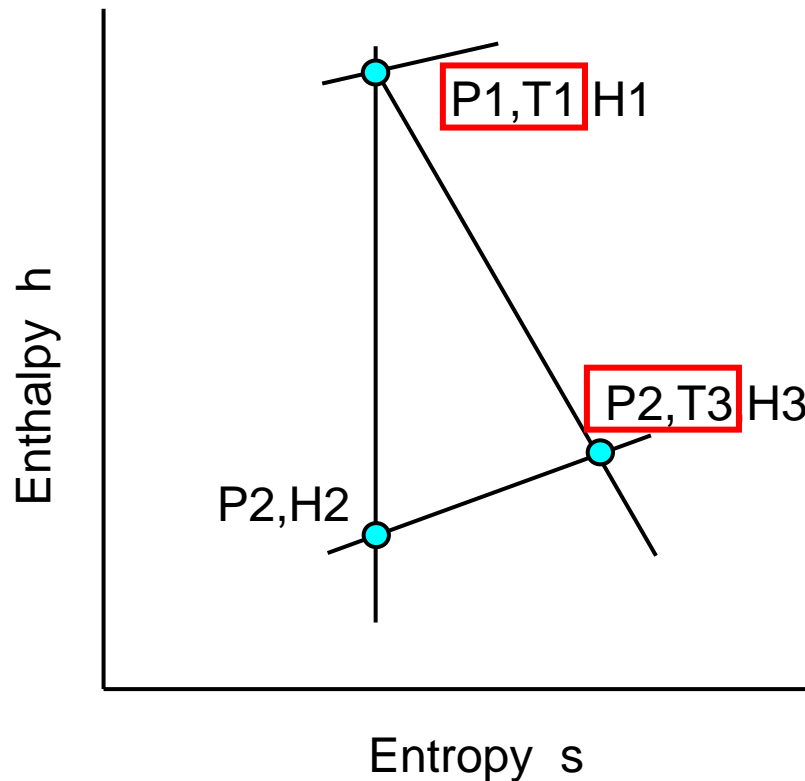
Turbine expansion curve

Turbine inner efficiency
$$= (H1 - H3) / (H1 - H2) \times 100 (\%)$$

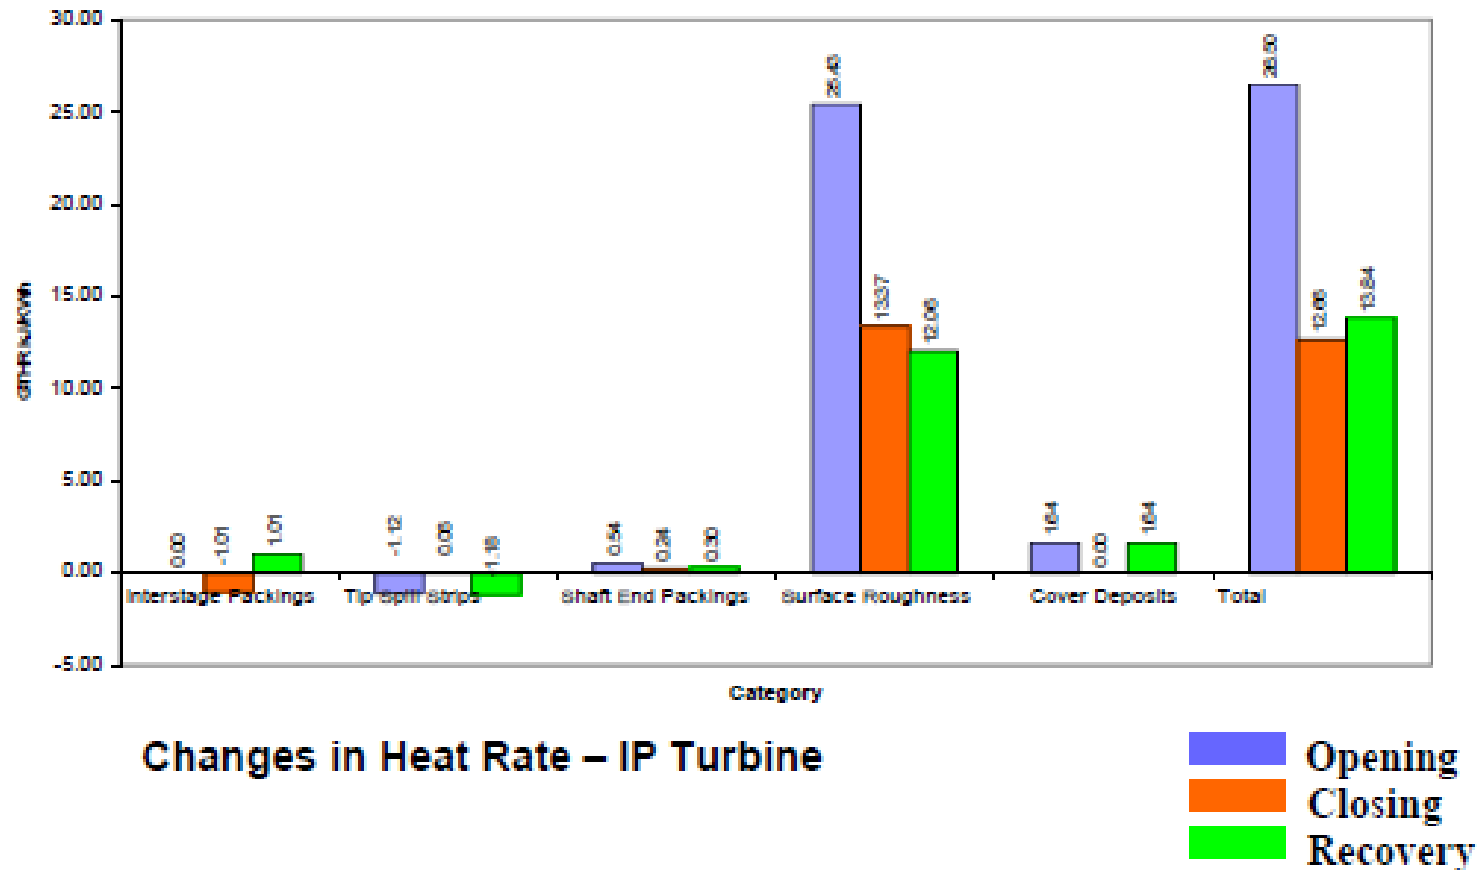
Result of SPA

- 1) Inspection of steam path component
Clearance, Roughness, Deposit, etc.
- 2) Estimation of performance losses
- 3) Calculation of losses in power and heat rate
- 4) Opening audit and Closing audit
